# STRUCTURE

NOVEMBER 2025

# Engineering Innovation in Seismic Retrofitting: Towne Storage Gateway

When a 2020 earthquake compromised the historic Towne Storage Gateway building in Salt Lake City, engineers faced the challenge of reinforcing its unreinforced masonry facade while maintaining its original architectural character. Through an advanced combination of retrofit techniques using FRCM and FRP, the team delivered a seismic upgrade that enhances structural integrity while preserving the building's historic character.

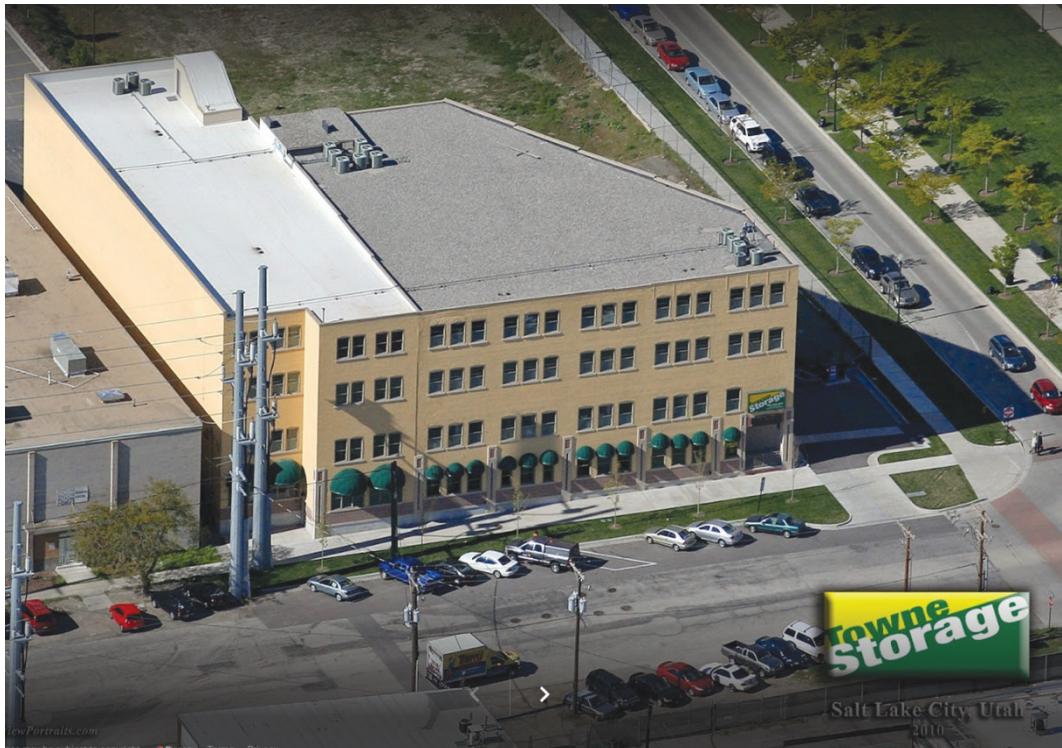
Systematic diagonal (shear) cracks appear between window groups.

**L**ocated in the heart of Salt Lake City, Utah, at 510 W 100 South, the Towne Storage Gateway building serves as a striking example of how structural engineering can preserve history while meeting modern safety standards. Originally constructed in 1920, this four-story structure, repurposed as a storage facility, faced daunting challenges when its south-facing exterior wall suffered significant damage during a March 2020 earthquake. Built using unreinforced masonry (URM), the wall—measuring 55 feet in height and 100 feet in length—was no match for the lateral seismic forces exerted against it. The damage included significant cracking in the three-wythe brick wall, detachment issues, and compromised structural integrity, necessitating extensive repairs. The wall was analyzed per ASCE 41 and determined to be part of the building's lateral system, requiring strengthening for in-plane shear and overturning moment forces based on seismic demands. To address these

The unreinforced masonry (URM) south facing facade, like many historical structures, was designed without embedded steel to resist tensile forces. URM walls rely entirely on the compressive strength of bricks and mortar as well as the bond strength between units and mortar, making them highly vulnerable to lateral forces caused by earthquakes. This was compounded by the presence of multiple window openings, which effectively creates small piers and spandrels where the stiffness and strength are reduced. Seismic activity led to diagonal shear cracking and weakening of the piers, leaving the wall unable to resist overturning loads or out-of-plane movement.

The engineering team, led by WCA Structural Engineering, evaluated the extent of the damage using visual inspections and structural analysis in accordance with ASCE 41-17 standards for seismic evaluation and retrofit. It was determined that the wall needed global in-plane shear strengthening, enhanced tensile capacity at the piers, and improved overturning resistance.

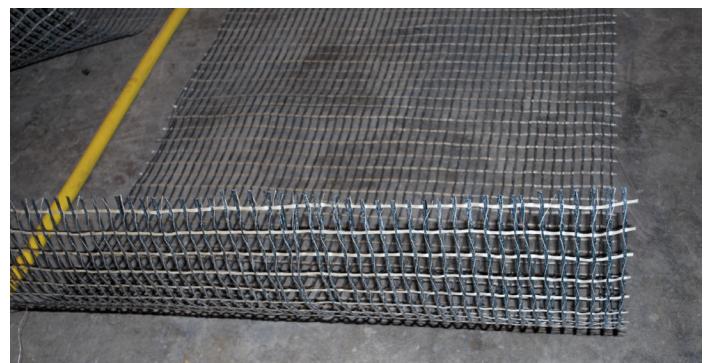
The FRCM system utilized for this project included both unidirectional and bidirectional, high-strength carbon fiber grid embedded in a portland-cement-based mortar. The cured composite tensile strength of the fiber grid is 128,300 psi for the unidirectional product, and 143,000 psi for the bidirectional product. The FRCM grid was applied in multiple layers to achieve a final thickness of approximately 1.5 inches.

The project's FRCM system used a unidirectional carbon fiber grid (shown) along with a bidirectional grid, embedded in a portland cement-based mortar.

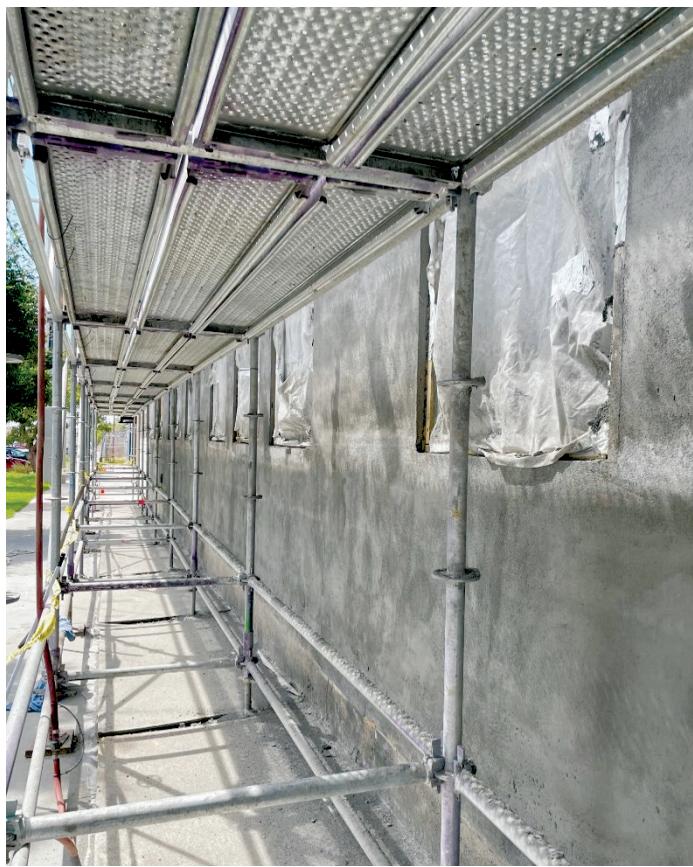
The finished FRCM application is shown after several layers of FRCM were applied and allowed to cure.

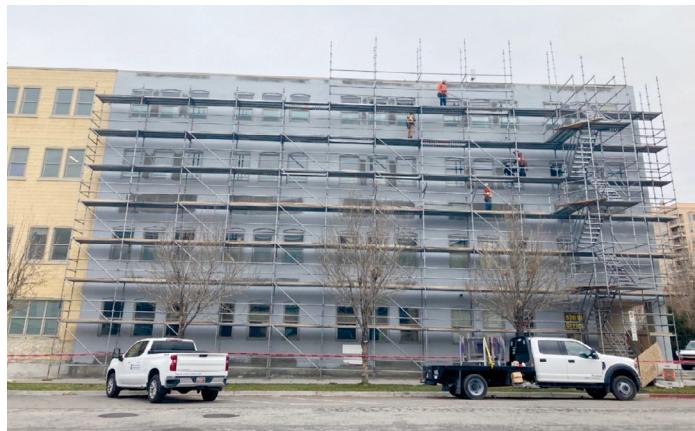
Final surface finishing provides aesthetic continuity.

Aesthetic continuity was restored by applying a textured coat overlay across the entire wall surface to ensure uniformity between treated and untreated areas.
